Manhole Inspection Summary

Manhole # S2500_010MH

Location Address: **914 CHAUNCEY AVE**

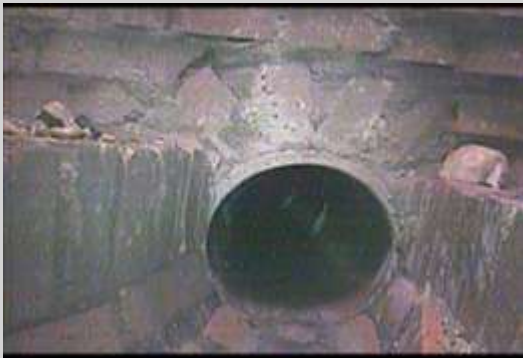
8 in. Circular Gravity Sewer Pipe Out @ 12 O'Clock

Invert Depth: **6.72** (ft.) Flow Characteristics: **Slow**

Infiltration: **None** Pipe Seal Cond: **Unknown**

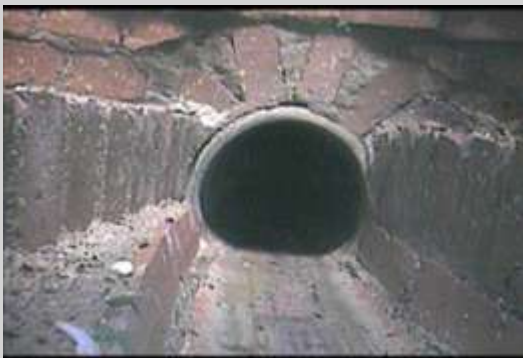
8 in. Circular Gravity Sewer Pipe In @ 7 O'Clock

Infiltration: **None** Pipe Seal Cond: **Unknown**
